Visual Home Inspection Report

101 Main Street, Eureka, CA

Inspected on: 11/15/2007

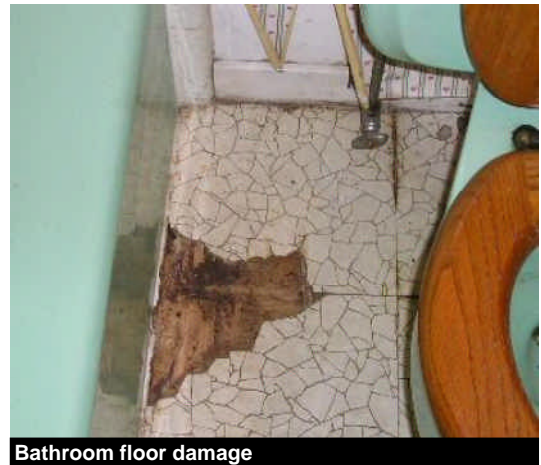
ACTION ITEM: Staining/discoloration and deterioration was noted near the toilet, which is likely due to moisture intrusion. Recommend further evaluation and repair as required by a qualified tradesperson.

Bathroom floor damage
